# Congressional Testimony for the Subcommittee on National Security, Emerging Threats, and International Relations

Hearing: "Occupational and Environmental Health Surveillance of Deployed Forces: Tracking Toxic Casualties"

# "One-Stop" Waste Disposal — Enhancing Force Protection in Afghanistan

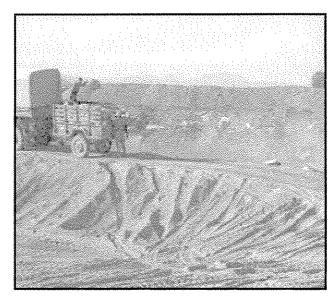
Soldiers dumping at the old burn pit were exposed to hazards of burning trash.

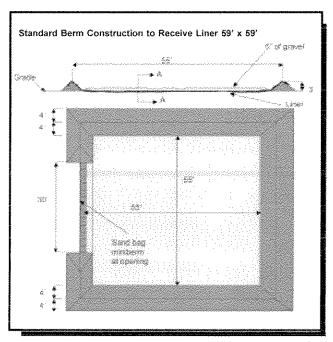
Hazardous waste holding cell design

The next stop was the hazardous waste holding area. This facility consisted of six bermed and lined cells, each 40 by 40 feet. Liners for the cells were unserviceable fuel bladders that

were drained, cut open, dried, laid flat, and covered with gravel. Soldiers then placed each type of waste (such as POL, batteries, and solvents) into separate designated cells, to comply with segregation requirements. Labeling standards were minimal to maintain simplicity and facilitate compliance with proper storage. Waste characterization, labeling, and preparation for shipment would be a task for the future base support contractor. Final disposal of hazardous waste would come later when a theaterwide disposal contract was in place. But until that time, the waste was effectively segregated, contained, and away from troop living and work areas.

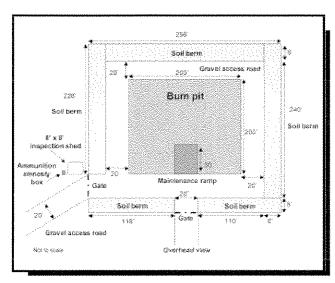
New burn pit design

Once all reusable materials and hazardous waste were dropped off, the unit vehicle could then proceed to the burn pit. The FET incorporated several features into the design and construction of the pit. Most importantly, it was controlled. The pit was surrounded by a berm and barbed wire, and the single point of entry was gated and manned by a guard, who inspected loads to ensure that only appropriate waste was placed in the pit. The entry also featured an ammunition amnesty box, which kept hundreds of dangerous rounds from being placed in the fire. The burn pit (250 by 250 feet in area and 12 feet deep) was large enough to have a reasonable life span of 2 to 3 years. The large size allowed safe standoff between areas of the pit that were actively burning or smoldering and designated spots where units would dump

their loads, minimizing the likelihood of an injury from exploding debris. An entrance ramp allowed access by dozers and compactors to perform routine maintenance, also extending the life of the pit.

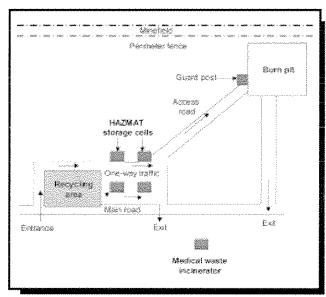
Layout of the one-stop waste disposal area

plan that effectively balanced simplicity with effectiveness. First, the new disposal area needed to be as far away from the main part of the camp as possible to minimize exposure to smoke. Second, sound waste disposal needed to be easy. If it is too difficult and complex to comply with the requirements, then midnight dumping occurs, making the problem even worse. The basic concept became "one-stop shopping" for all disposal requirements—all forms of waste disposal located in one spot. This allowed a logical and controlled process that made it easy for units to comply. This facility, with easy access from the road, consisted of a recycling area, hazardous waste storage cells, a medical waste incinerator, and a large burn pit with controlled access.
